Higher quality of life – lower heating costs

Up to 90 % energy savings by renovation

A Technical Guide to the
Thermal Renovation of old buildings.

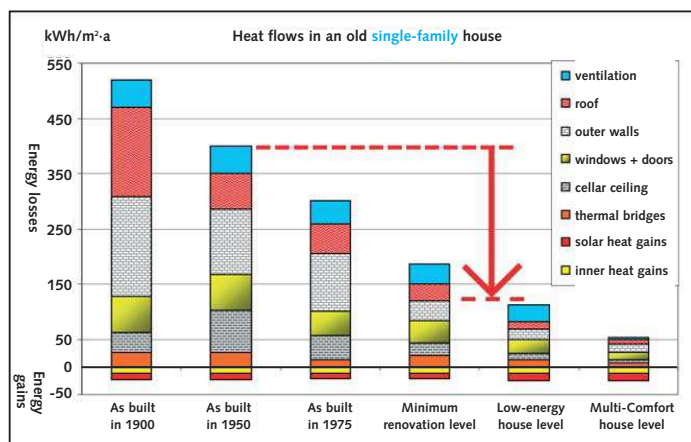
The following bar chart shows the heat flows of the most important building components of this house when built according to the 1900, 1950 (real) and 1975 level of thermal insulation. In addition, the chart shows the values achieved with three other variants of thermal renovation. The heating demands range from 490 to 29 kWh/m²a; possible heating savings range from 50 to 90 %. The bars in the chart show the heat losses (above zero) as well as the heat gains (below zero). The losses have to be compensated by the gains.

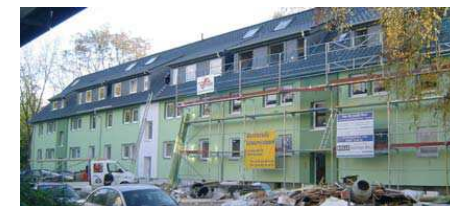
Saving effects in an old multi-family house

This house from the early 1950s is a typical example that you find in many housing estates of German towns. It has a living area of 1000 m², subdivided into 24 flats accessible via 6 staircases, and is located in a colony with about 30 identical ones. Its cellar and loft were not heated. Its original construction corresponds to the one described in the technical data table (as built in 1950). In 2006, it was completely renovated to a level superior even to new buildings.

The 30 cm thick brick walls received 14 cm of external insulation. The pitched roof on the 3rd floor level was opened from outside and insulated with a layer of 24 cm. The upper ceiling was opened from the top and also received an insulation layer of 24 cm thickness. The single-glazed windows with wooden frames were replaced by new wooden windows with heat-saving double glazing. In this process, in every flat two south-facing windows were enlarged. The concrete floor on the ground level was insulated from the top with a layer of 8 cm thickness, the old wooden floor was removed that was laid with 6 cm air space between the boards and the concrete. The front and cellar doors were replaced. Mechanical ventilation was not installed. A new, highly efficient gas heating system was installed in each of those 6 flats under the roof that are located above staircases. The heating demand could be reduced from about 310 kWh/m²a down to 90 kWh/m²a.

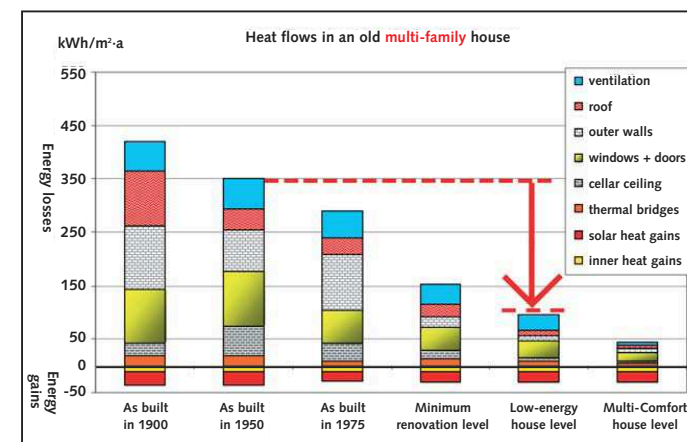
The following bar chart shows the heat flows of the most important building components of this house when built according to the 1900, 1950 (real) and 1975 level of thermal insulation. In addition, the chart shows the values achieved for three other variants of thermal renovation. The heating demands range from 382 to 14 kWh/m²a whereas the possible heating savings range from 50 to 90 %. The bars in the chart show the heat losses (above zero) as well as the heat gains (below zero). The losses have to be compensated by the gains.

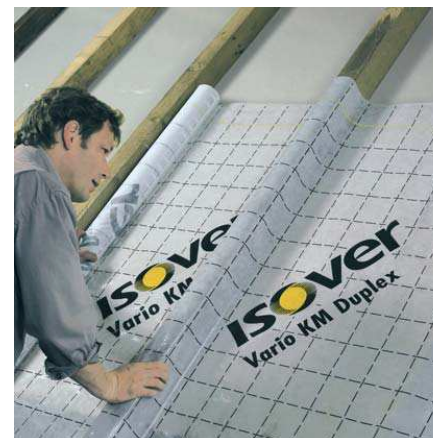
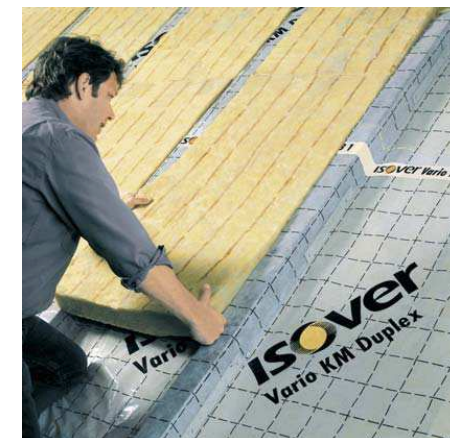
The left column shows pitched roofs before renovation as described in the previous chapter. They differ in the amount of existing insulation and the quality of inner air-sealing and vapour-retarding layers. Their outer covering is of no importance here as it will be completely removed when renovating the roof from outside. Columns 2, 3 and 4 show how these different old roofs can be improved to the level of new houses, low-energy houses and Multi-Comfort houses. To reach the roof insulation level of a new house, a 4 cm lath is fixed onto the existing 16 cm rafters and an insulation layer of 20 cm is installed. To reach low-energy house level, joists of 14 cm height are fixed on the existing rafters and a total insulation layer of 30 cm is installed. To reach Multi-Comfort or passive house level, 24 cm TJI joists are screwed on top of the rafters and a total insulation layer of 40 cm is built in.

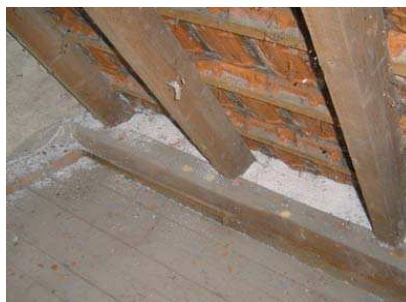
Loose granule fill between rafters made of expanded shale

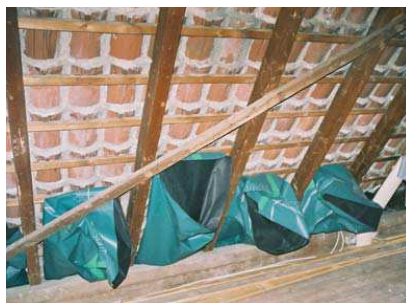
Vapour-permeable bags placed between rafters to cover later blown-in insulation

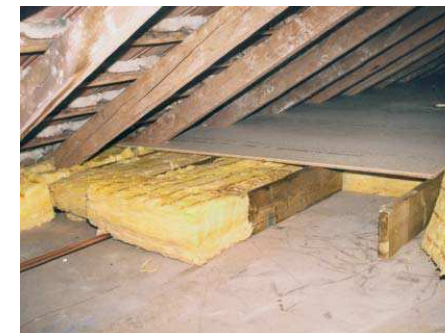
Top side mineral wool insulation and chipboard on wooden spacers

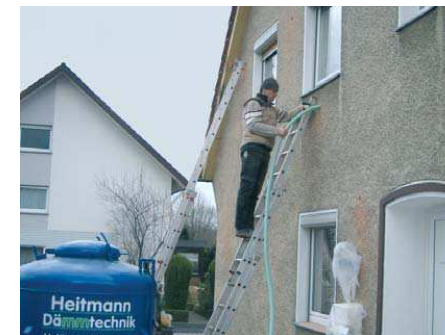
Blowing granular perlite insulation into a cavity wall

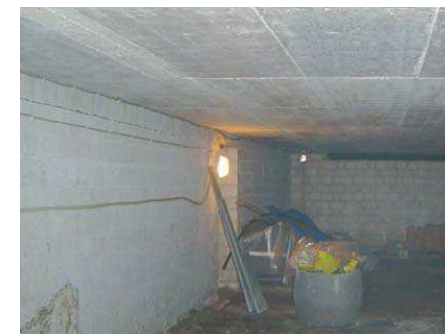
Concrete cellar ceiling without insulation. High U-value = 2.2 W/m². 10 cm insulation from below can reduce heat losses by 85 %

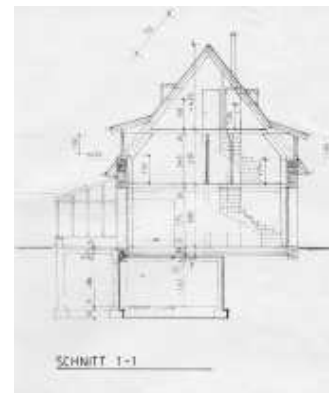
Cross-section of the barn

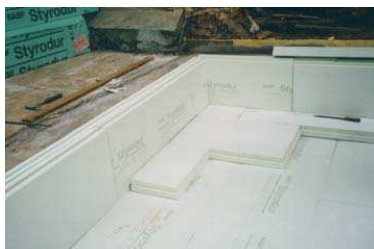
Two-layered insulation with Styrodur 5000 floor boards within the ring footing for the natural stone walls

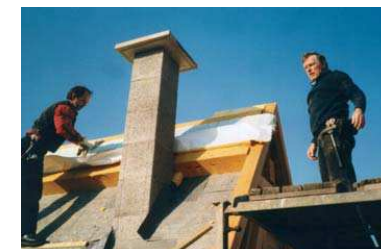
Installation of above-rafter insulation on the ridge

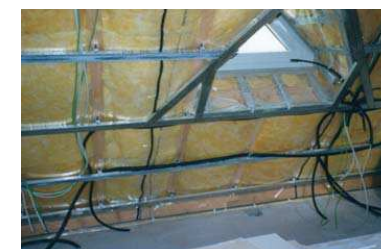
Roof construction in the dormer area with separate installation layer

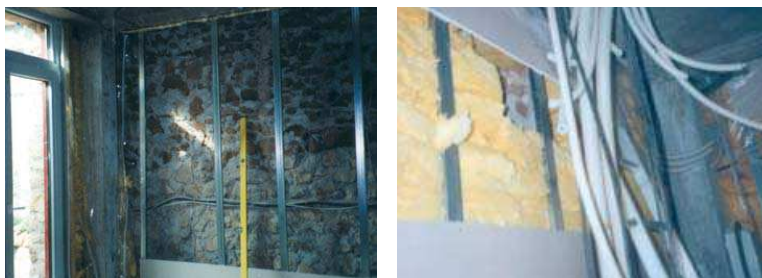
Metal frame construction facing the natural stone wall

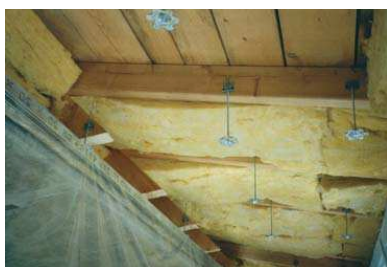
Ceiling construction of the shed dormers with ROSATWIST

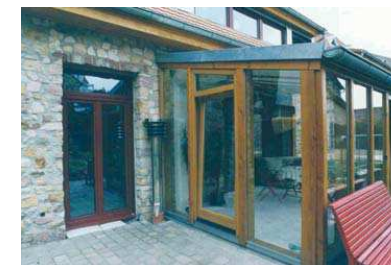
Fresh air routing of the geothermal heat exchanger via the terrace
